# Manhole Inspection Summary

Manhole # S23K\_\_037MH

**Location** Address: **300 S Calhoun St**

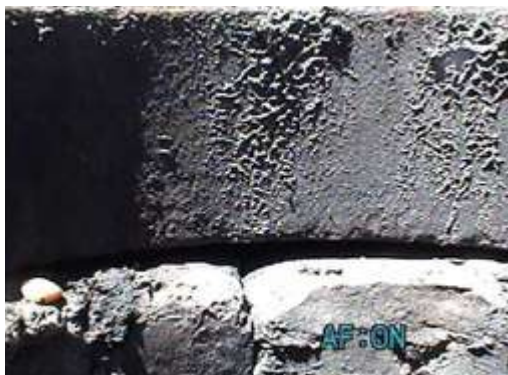
Defect 5

broken bricks, infiltration @ frame chimney joint

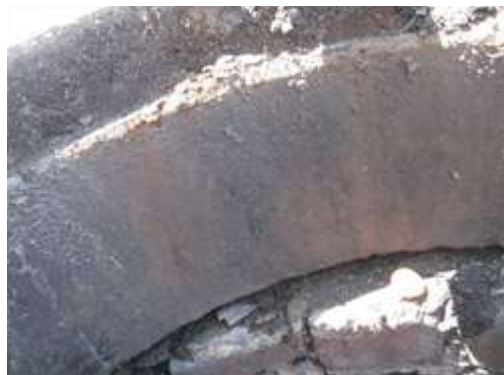
Defect 4

frame-lid infiltration

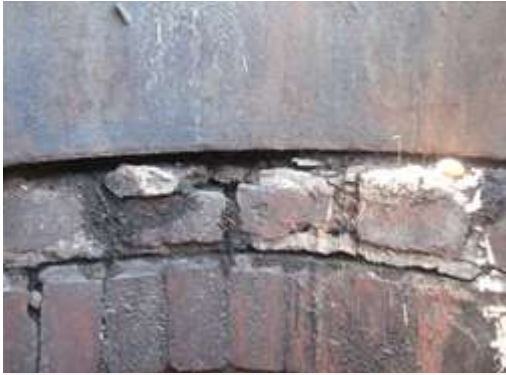
Defect 6

infiltration from frame-chimney joint

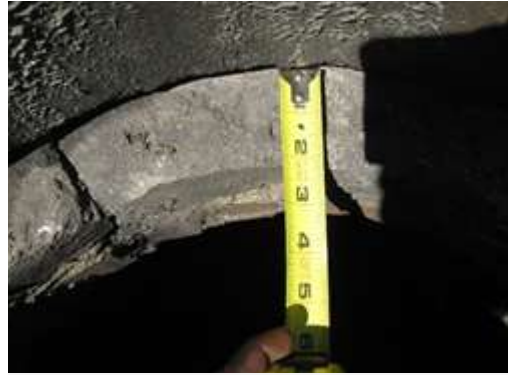
Defect 3

2.5" frame offset

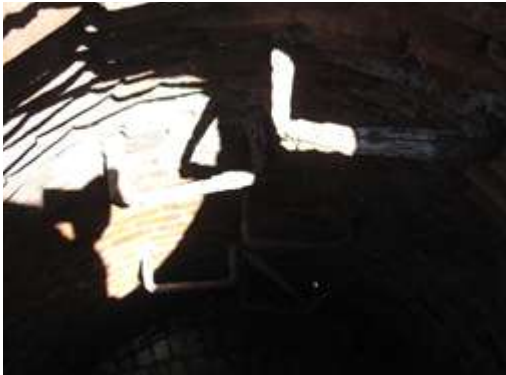
corroded rungs

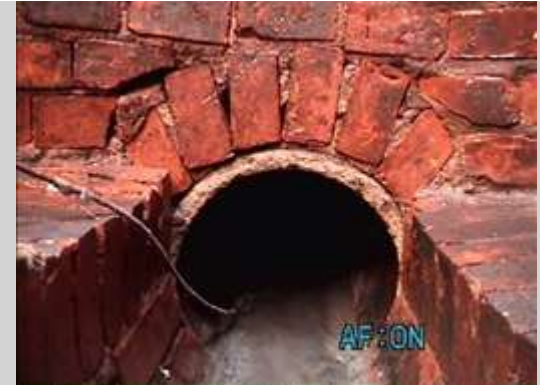
12 O'Clock Outflow

12 in. Circular Gravity Sewer  
Pipe Out @ 12 O'Clock

Pipe Height: **12** (in.) Rod and Bar (Angled)  
Pipe Material: **Clay** ☐ Pipe Lined  
Invert Depth: **9.22** (ft.) Flow Characteristics: **Fast**  
Deposits: ☒ None ☐ Mud ☐ Sludge ☐ Debris ☐ Grease  
Silt Depth: **0** (in.) Deposits Extent:  
Infiltration: **None** Pipe Seal Cond: **Sound**

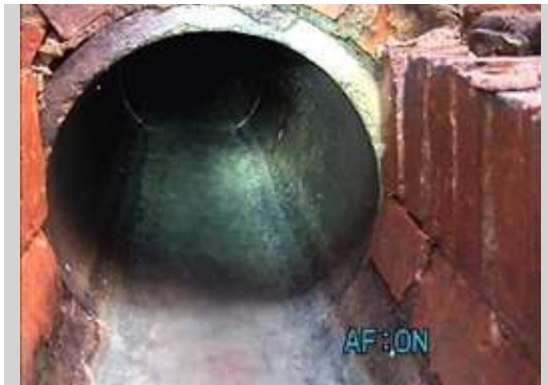
5 O'Clock Inflow

10 in. Circular Gravity Sewer  
Pipe In @ 5 O'Clock

Pipe Height: **10.8** (in.) Rod and Bar (Angled)  
Pipe Material: **Clay** ☐ Pipe Lined  
Invert Depth: **9.00** (ft.) Flow Characteristics: **Slow**  
Deposits: ☒ None ☐ Mud ☐ Sludge ☐ Debris ☐ Grease  
Silt Depth: **0** (in.) Deposits Extent:  
Infiltration: **None** Pipe Seal Cond: **Sound**
